NSWCCD-65-TR-2005/24 October 2005

### **Structural Irregularity and Damage Evaluation Routine (SIDER) for Testing of the 1/2-Scale Corvette Hull Section Subjected to UNDEX Testing**

Subj: SIDER NDE INSPECTION OF A 1/2-SCALE CORVETTE HULL SECTION

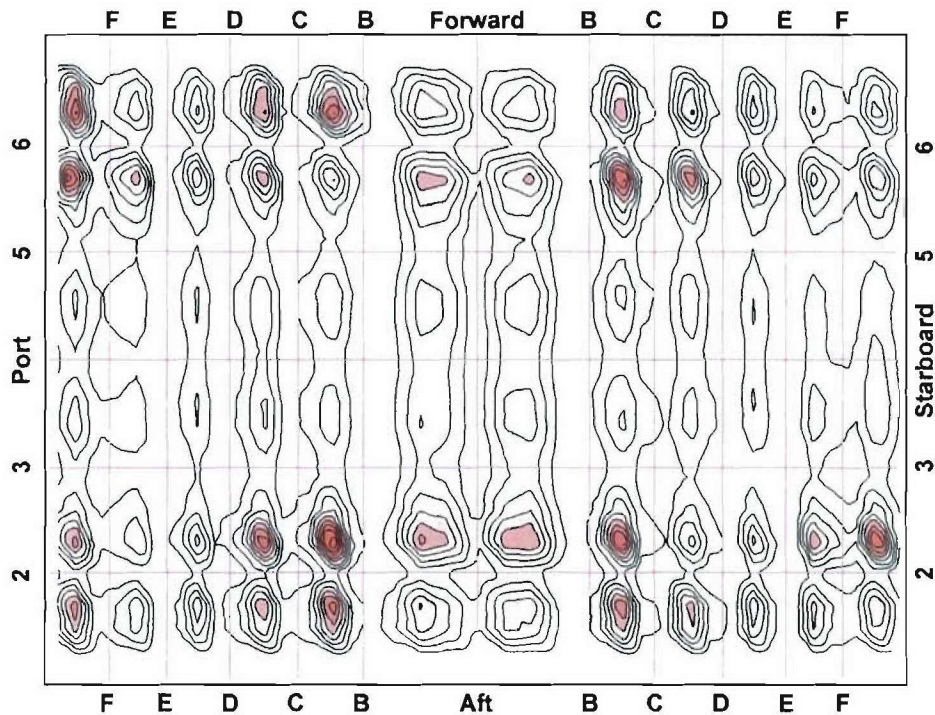
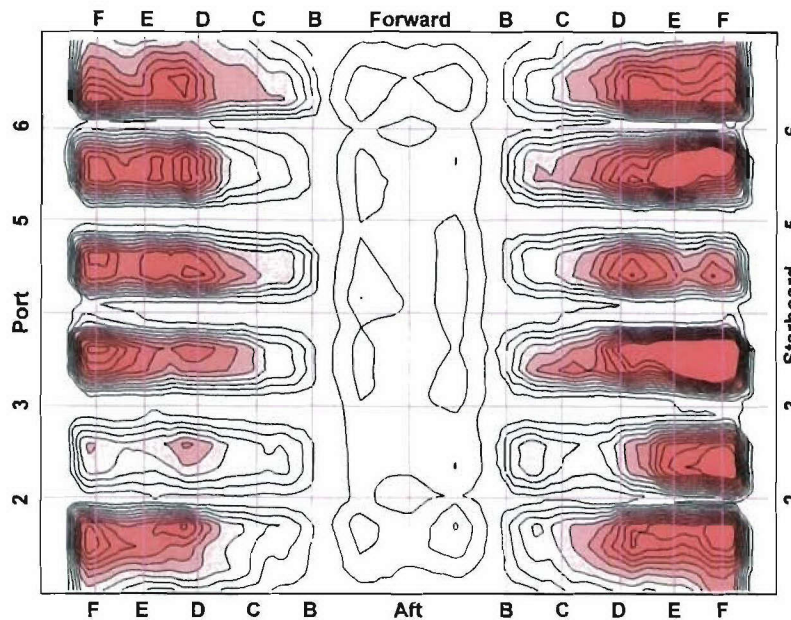
The fore/aft analysis has identified the stiffness changes associated with the stiffener pattern. It has also identified that the bulkheads (athwart ships at stiffener locations 2 and 6) generate more stiffness variation than the other stiffeners.

The athwartships analysis has identified that the stiffness in the bays between the stiffeners continuously changed from the keel to the upper deck. This is consistent with the manufacture, where there are progressive ply drops from the keel to the upper deck. Figure 8 shows that there are structural differences in the hull. Comparing the port and starboard SIDER results, there is a definite lack of symmetry in the regions between the bays. This is especially evident in the region between the aft bulkhead 2 and stiffener 3.

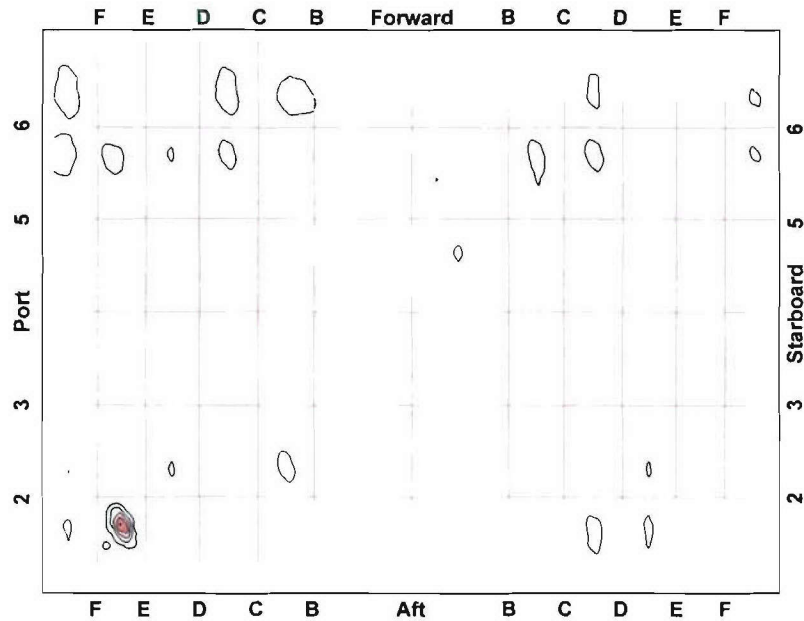
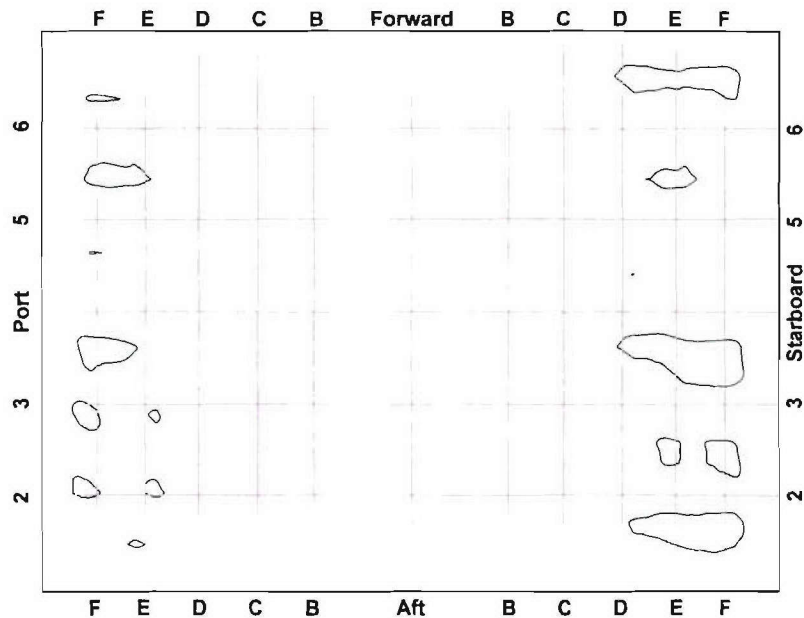
susceptibility to the structural mass loading and noise issues discussed above. However, there was a measurable difference at an area on the port side between longitudinal stiffeners F and E and near bulkhead frame 2 as seen by the only red region on the figures.

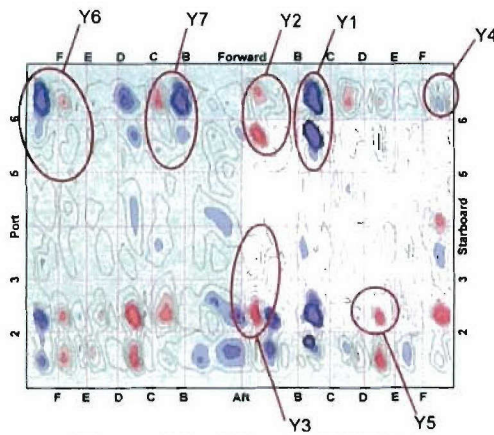
Figure 20. After UNDEX 2

UNDEX 1 or 2 caused some structural change, probably a relaxation of tabbing. There was no further development with later UNDEX.

Steady progress of localized structural change with increasing UNDEX. This is the location where the external ply buildup failed after UNDEX 3; see Figure 23.

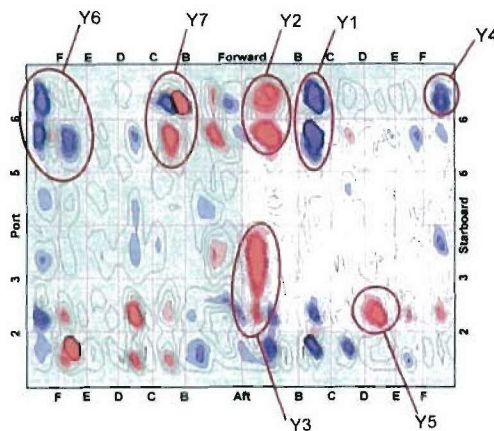
Figure 22. After UNDEX 4

Early indications after UNDEX 2 with significant change during UNDEX 4.

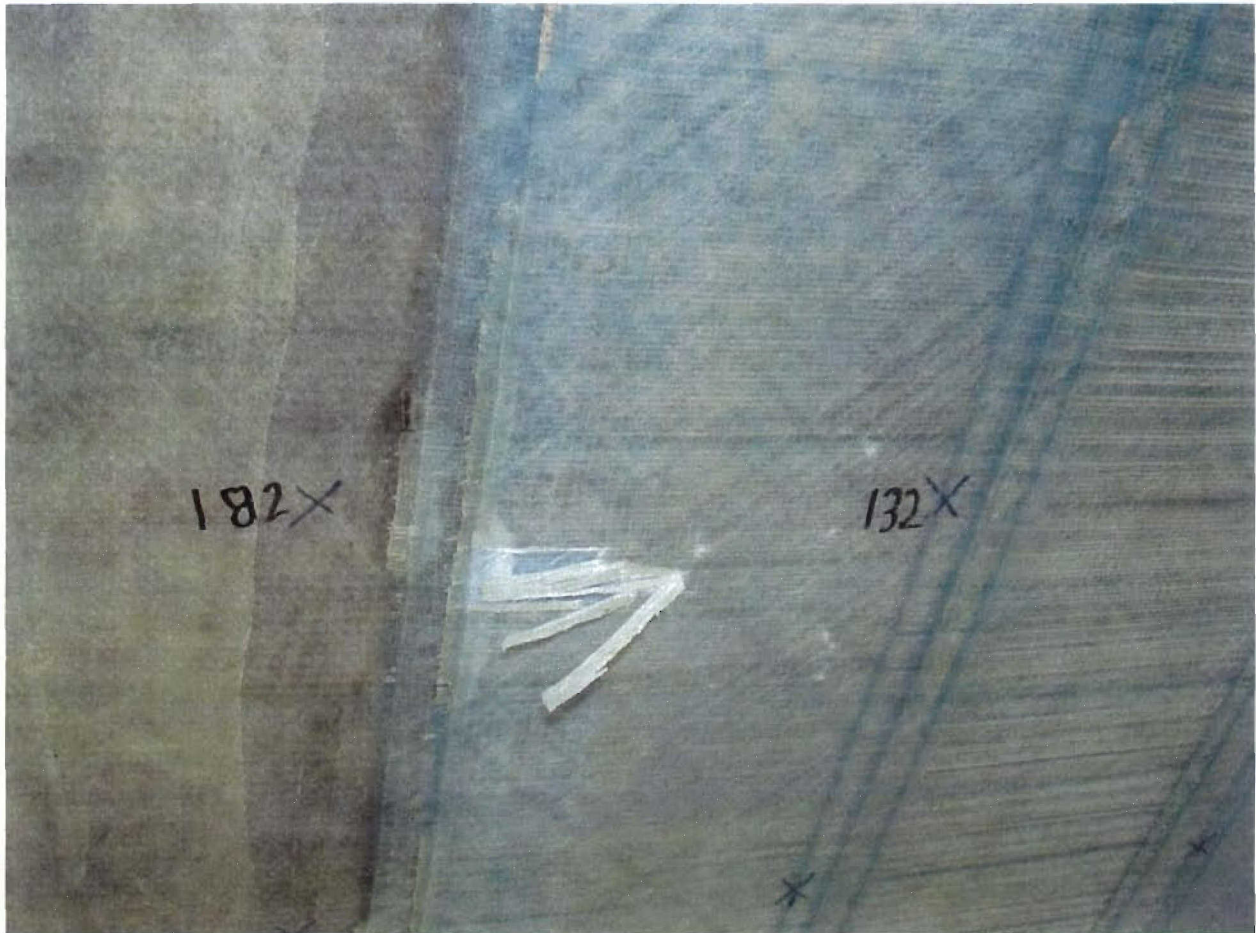
Figure 23. External Ply Buildup Failure after UNDEX 3

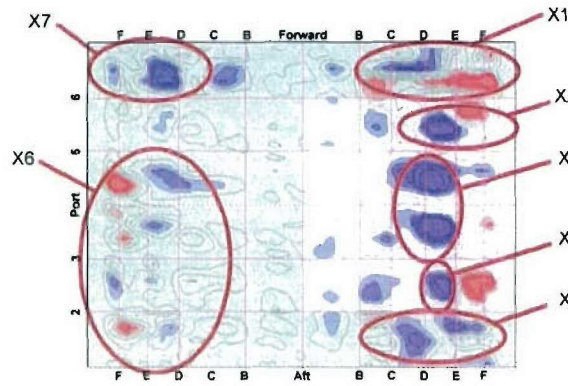
Figure 24. After UNDEX 2

UNDEX2 caused this blue area to appear. After UNDEX 4 this area disappeared. The change from blue toward red (stopping at white) is indicative of a significant structural change.

A rapidly developing area indicative of tabbing relaxation aft of the aft bulkhead.

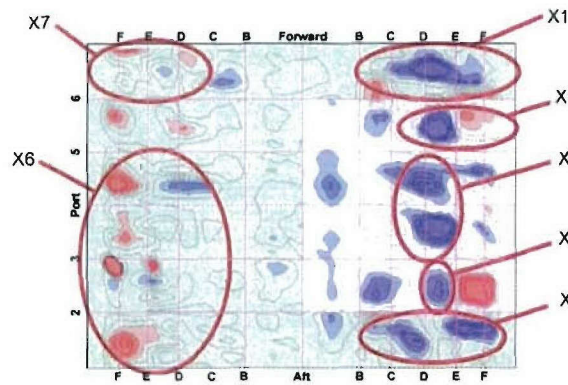
Figure 25. After UNDEX 3

This large port side area shows steady development with UNDEX. It is interesting to note that the port side is predominantly red, whereas the starboard side is predominantly blue. This suggests the two sides saw different types of damage.

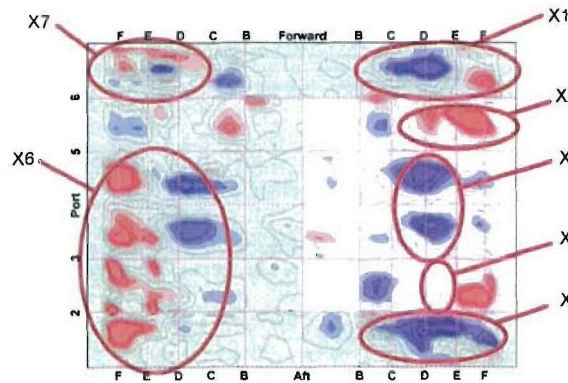
Figure 26. After UNDEX 4

A strong feature on the ply buildup starboard side, forward of the forward bulkhead, that developed after UNDEX 4.

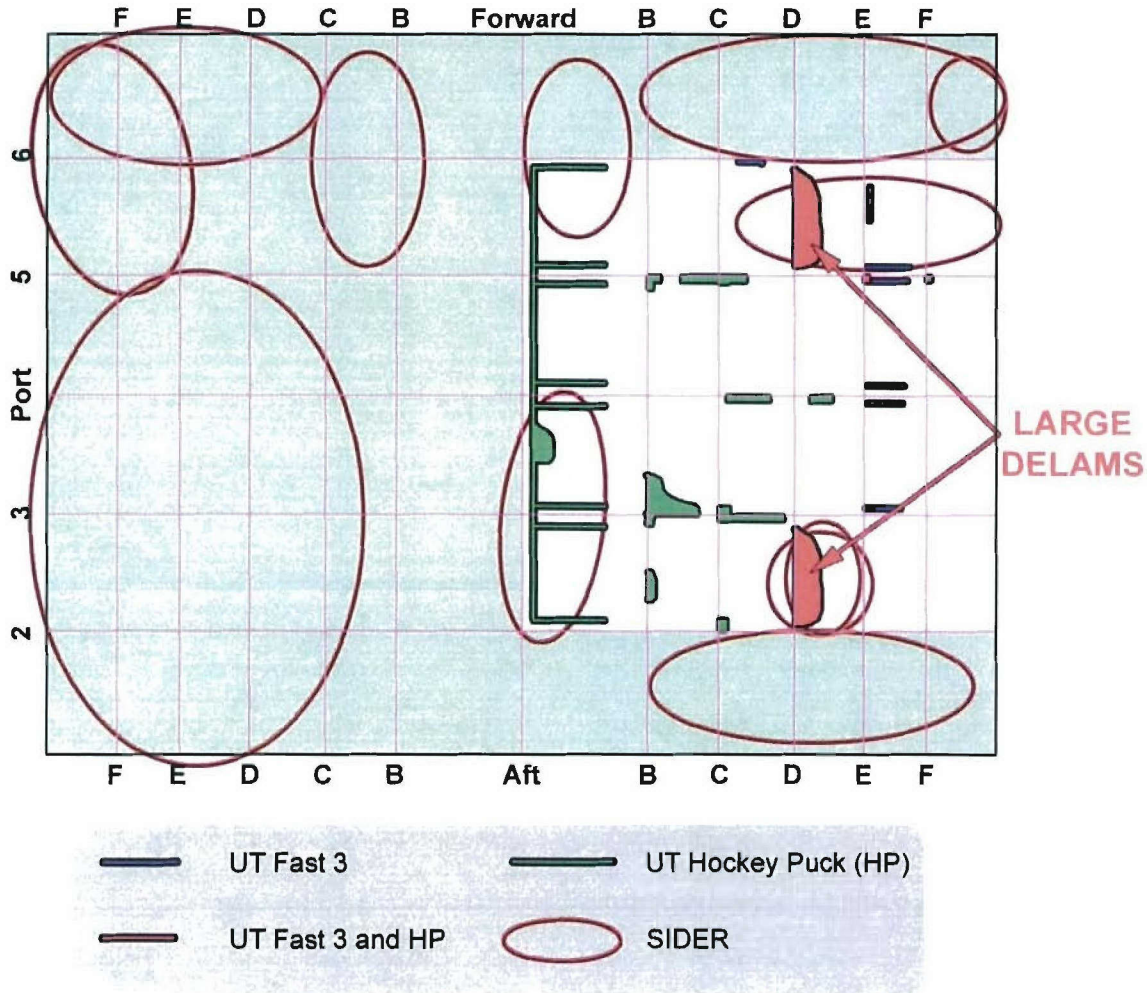
**Figure 27. VT/UT F3 and HP Identified Regions Compared with Areas of Concern Identified by SIDER**

- VT/UT only tested about one-half of the starboard side. SIDER found several areas of concern in other areas that were not VT/UT tested.
- There were only two significant delaminations. Both were inside areas identified by SIDER as places of concern.

- SIDER is designed to screen an entire structure and then use its findings to direct more detailed inspection methods. As such, it locates the most significant areas, and not necessarily all damage sites. SIDER achieved this aim, since, within the area that was VT/UT inspected, all SIDER identified regions had VT/UT indications of damage.

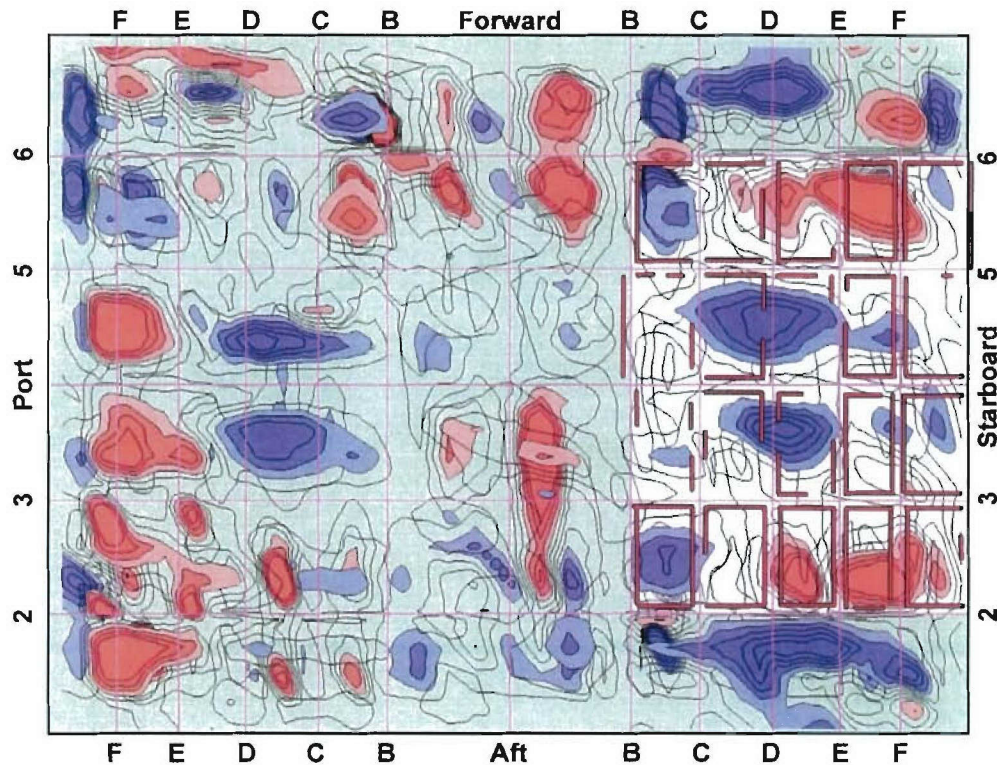
Figure 28 shows the VT/UT ZIP probe results compared with the combined athwartships and fore/aft SIDER difference results. While many of the SIDER features are coincident with ZIP findings, the ZIP results are not ranked for degree of severity and this precludes making a meaningful comparison. Other than presenting the results as-is, further comparison and discussion is neither warranted nor made in this report. Note that the VT/UT tested area for this probe was slightly smaller than the area VT/UT tested with the other probes.

**Figure 28. VT/UT Indications of Radius Problems Identified with ZIP Probe Compared with the Combined Athwartships and Fore/Aft SIDER Difference Results**
